## Runway Pavement “Abraded” at Roswell International Air Center

*Skidabrader enhances pavement surface texture to meet FAA friction level standards.*

By Dennis Corsi, C.M.

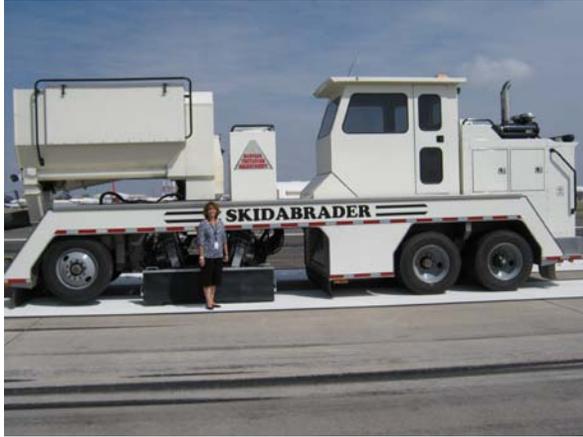
Jennifer Brady, Roswell International Air Center Manager, with Skidabrader equipment.

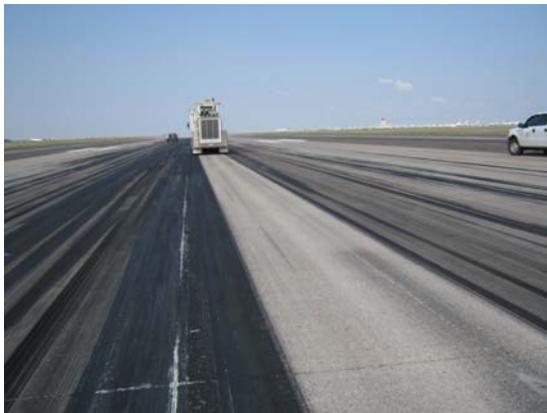
First Skidabrader treatment pass on test section.

The project commenced in July 2013. Upon arrival on site, John Swain the Skidabrader project manager, explained, "The Skidabrader machine can be fine-tuned to provide a desired effectiveness by varying the speed of the equipment across the ground. A slower speed, 100 feet per minute for example, provides a heavier or more aggressive treatment than a faster speed across the ground, such as 135 feet per minute." The objective of the treatment was to provide a surface texture that would result in friction levels far enough above the maintenance planning level to meet FAA standards and offer long-term results, while avoiding too rough of a pavement for aircraft certification testing. Hi-Lite

The Skidabrader machine was calibrated along 250-foot test sections by varying the Skidabrader ground speed and testing the resulting friction levels. Different speeds were selected for the touchdown zones, which are more heavily utilized and highly contaminated with rubber deposits, and for the center and outer portions of the runway. Using a No. 390 steel shot blast, the Skidabrader machine propels the shot at the pavement, immediately vacuums the shot and pavement residue into its hopper, magnetically separates the shot blast from the

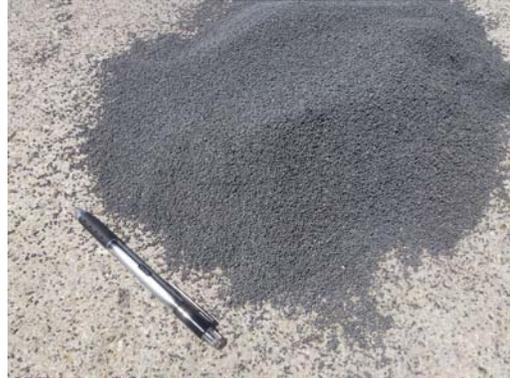
*No. 390 steel shot blast used in the Roswell Skidabrader treatment.*

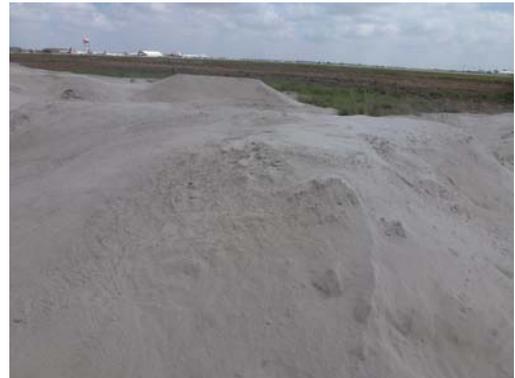
*Concrete waste material "dust" pile.*

pavement debris, screens and re-uses the suitable shot pellets, sends the unusable shot to a separate hopper and stores the fine powdery concrete residue in another hopper for disposal.
